CASE STUDY: Geo-Seal[®] Favored by Engineer over Simple Spray-Applied Membrane for More Effective Chemical Resistance

Compass Bank – Birmingham, AL

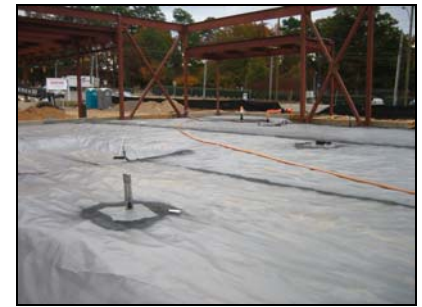
Geo-Seal BASE layer

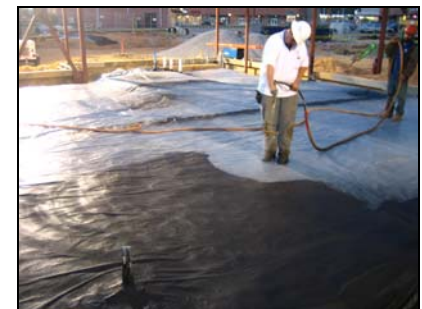
Geo-Seal spray-applied CORE layer application

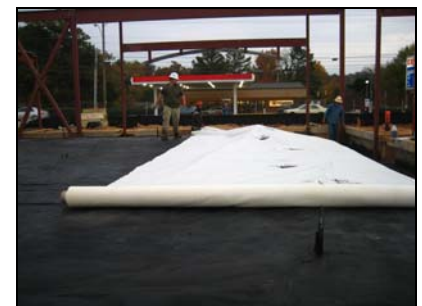
Geo-Seal BOND layer application
